## *WALL THERMOGRAPHY*

### **Accent Building Sciences Inc**

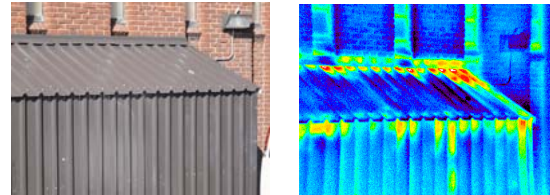
**Figure 1:** Conductive heat loss from exterior walls and roof due to poor placement of insulation.

Conduction losses from building wall assemblies are a direct result of heat transfer through building materials. This could be caused by insufficient and poor placement of insulation materials and thermal bridging of different assemblies due to poor construction details.

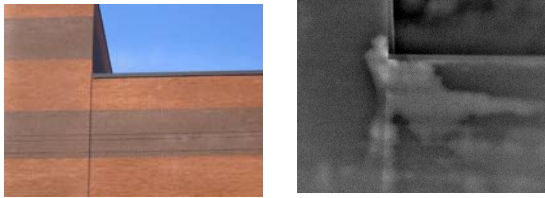
**Figure 2:** Convection heat loss from exterior wall/flat roof perimeter detail, due to lack of continuous wall/roof air barrier.

Convection losses from building wall assemblies are related to air tightness of different wall elements and their performances. Improperly applied caulking, poor detailing of wall air barriers, windows

and wall/roof junctions are a few examples related to air leakage from exterior building walls.

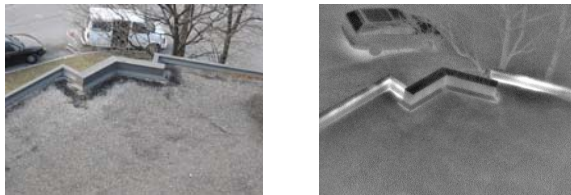
**Figure 3:** Convection heat loss at wall corner/flat roof perimeter detail. Masonry brick wall appears to be wet, due to moist warm interior air ex-filtrating through exterior wall system.
